Implementation of a Vibration Risk Reduction programme at a heavy engineering manufacturing company

Julie Hills – SAIOH August 2011

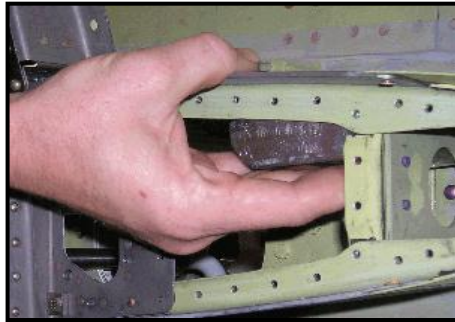
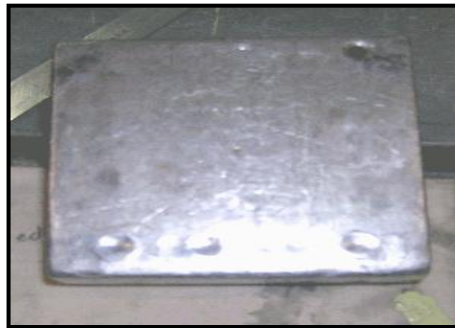
Old Process

Exposure: – **VERY High**

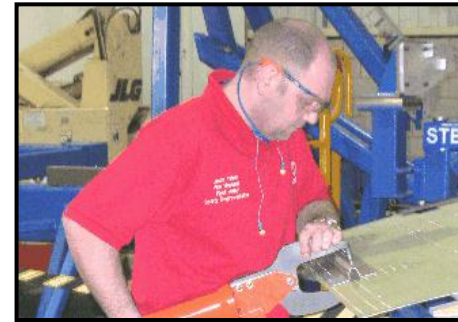
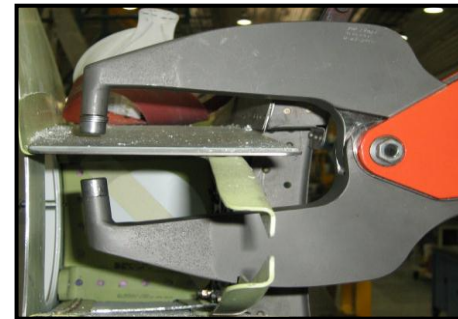
New Process

Exposure: – **Negligible**

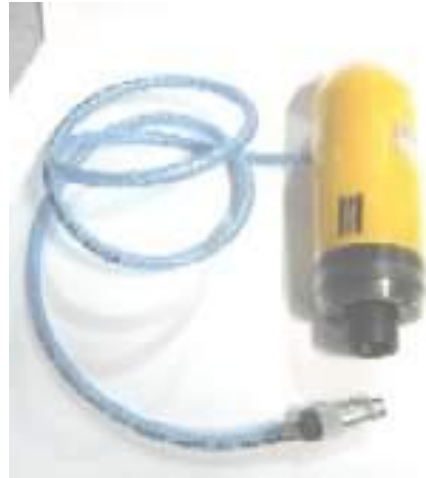
Process improvements

PNEUMATIC
DAMPENER
15% more
effective than
sprung

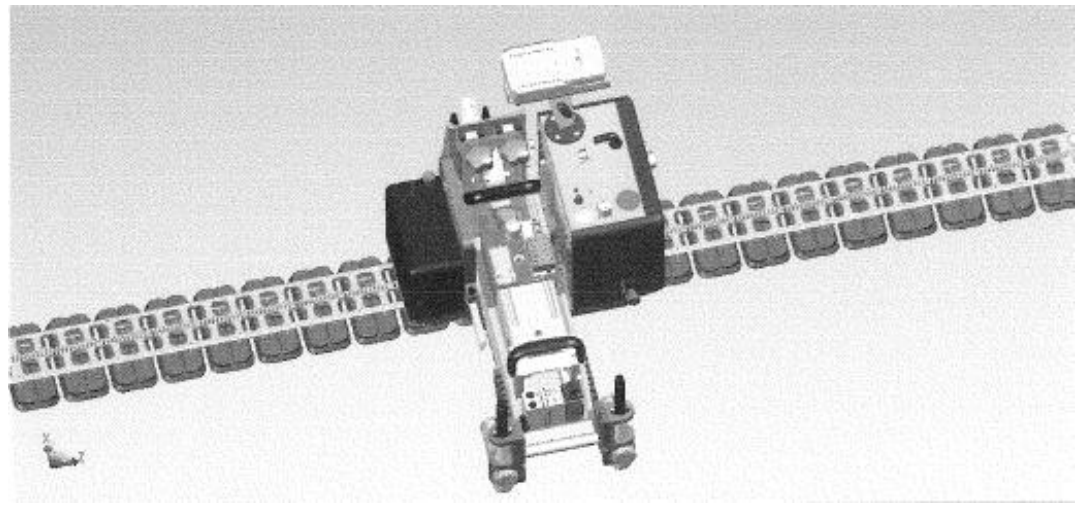
- ▶ The aim is to reduce worker exposure by elimination of the vibration problem – automation, safer tooling etc.
- ▶ Some examples of vibration reduction measures identified and undergoing implementation included:
 - For high volume holes, an automated system is proposed. This will entirely remove the operator from the machine function.
 - Prototypes are in manufacture with introduction into production planned to start late 2009

- ▶ For large diameter holes and countersinks the operator input is now reduced to locating the machine on to a fixture.
- ▶ The remainder of the process is automated.
- ▶ 26 machines were purchased within the 12 week period!

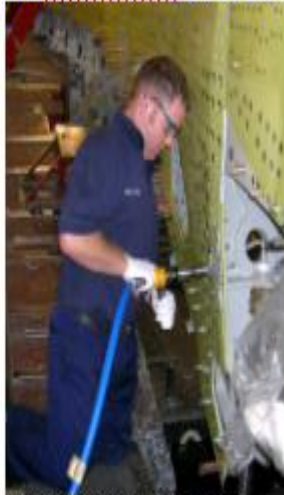
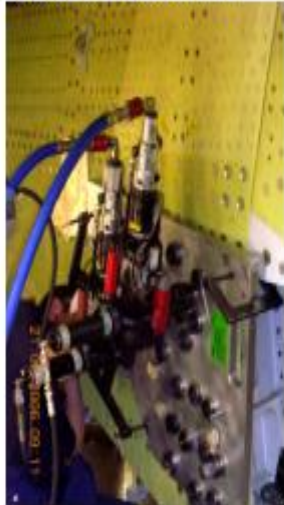
TARGET CONDITION – TAPERLOCKING PROCESS

| Reduction of Vibration | |
|---|---|
| <p>Manual taperlocking process</p> <p>■ Typical exposure levels:</p> | <p>Process and tool modification</p> <p>■ No exposure: Tool locked onto jig and automatic drilling occurs. Exposure level 0</p> |

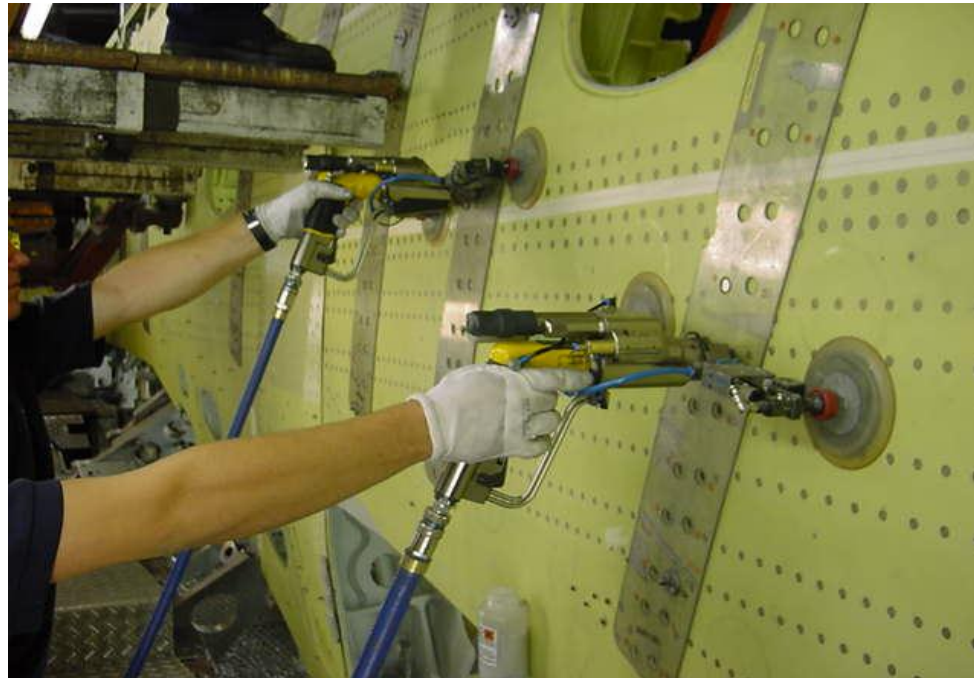
- ▶ Pistol drill has been developed so that the location is now via vacuum pads.
- ▶ The axial feed is semi-automatic.
- ▶ The machine combines 3 manual drilling operations.
- ▶ Phased implementation into main production areas
